Debris/Ice/TPS Assessment And Photographic Analysis For Shuttle Mission STS-33R

Charles G. Stevenson
NASA/Kennedy Space Center

DEBRIS/ICE/TPS ASSESSMENT
AND
PHOTOGRAPHIC ANALYSIS
OF
SHUTTLE MISSION STS-33R

November 22, 1989

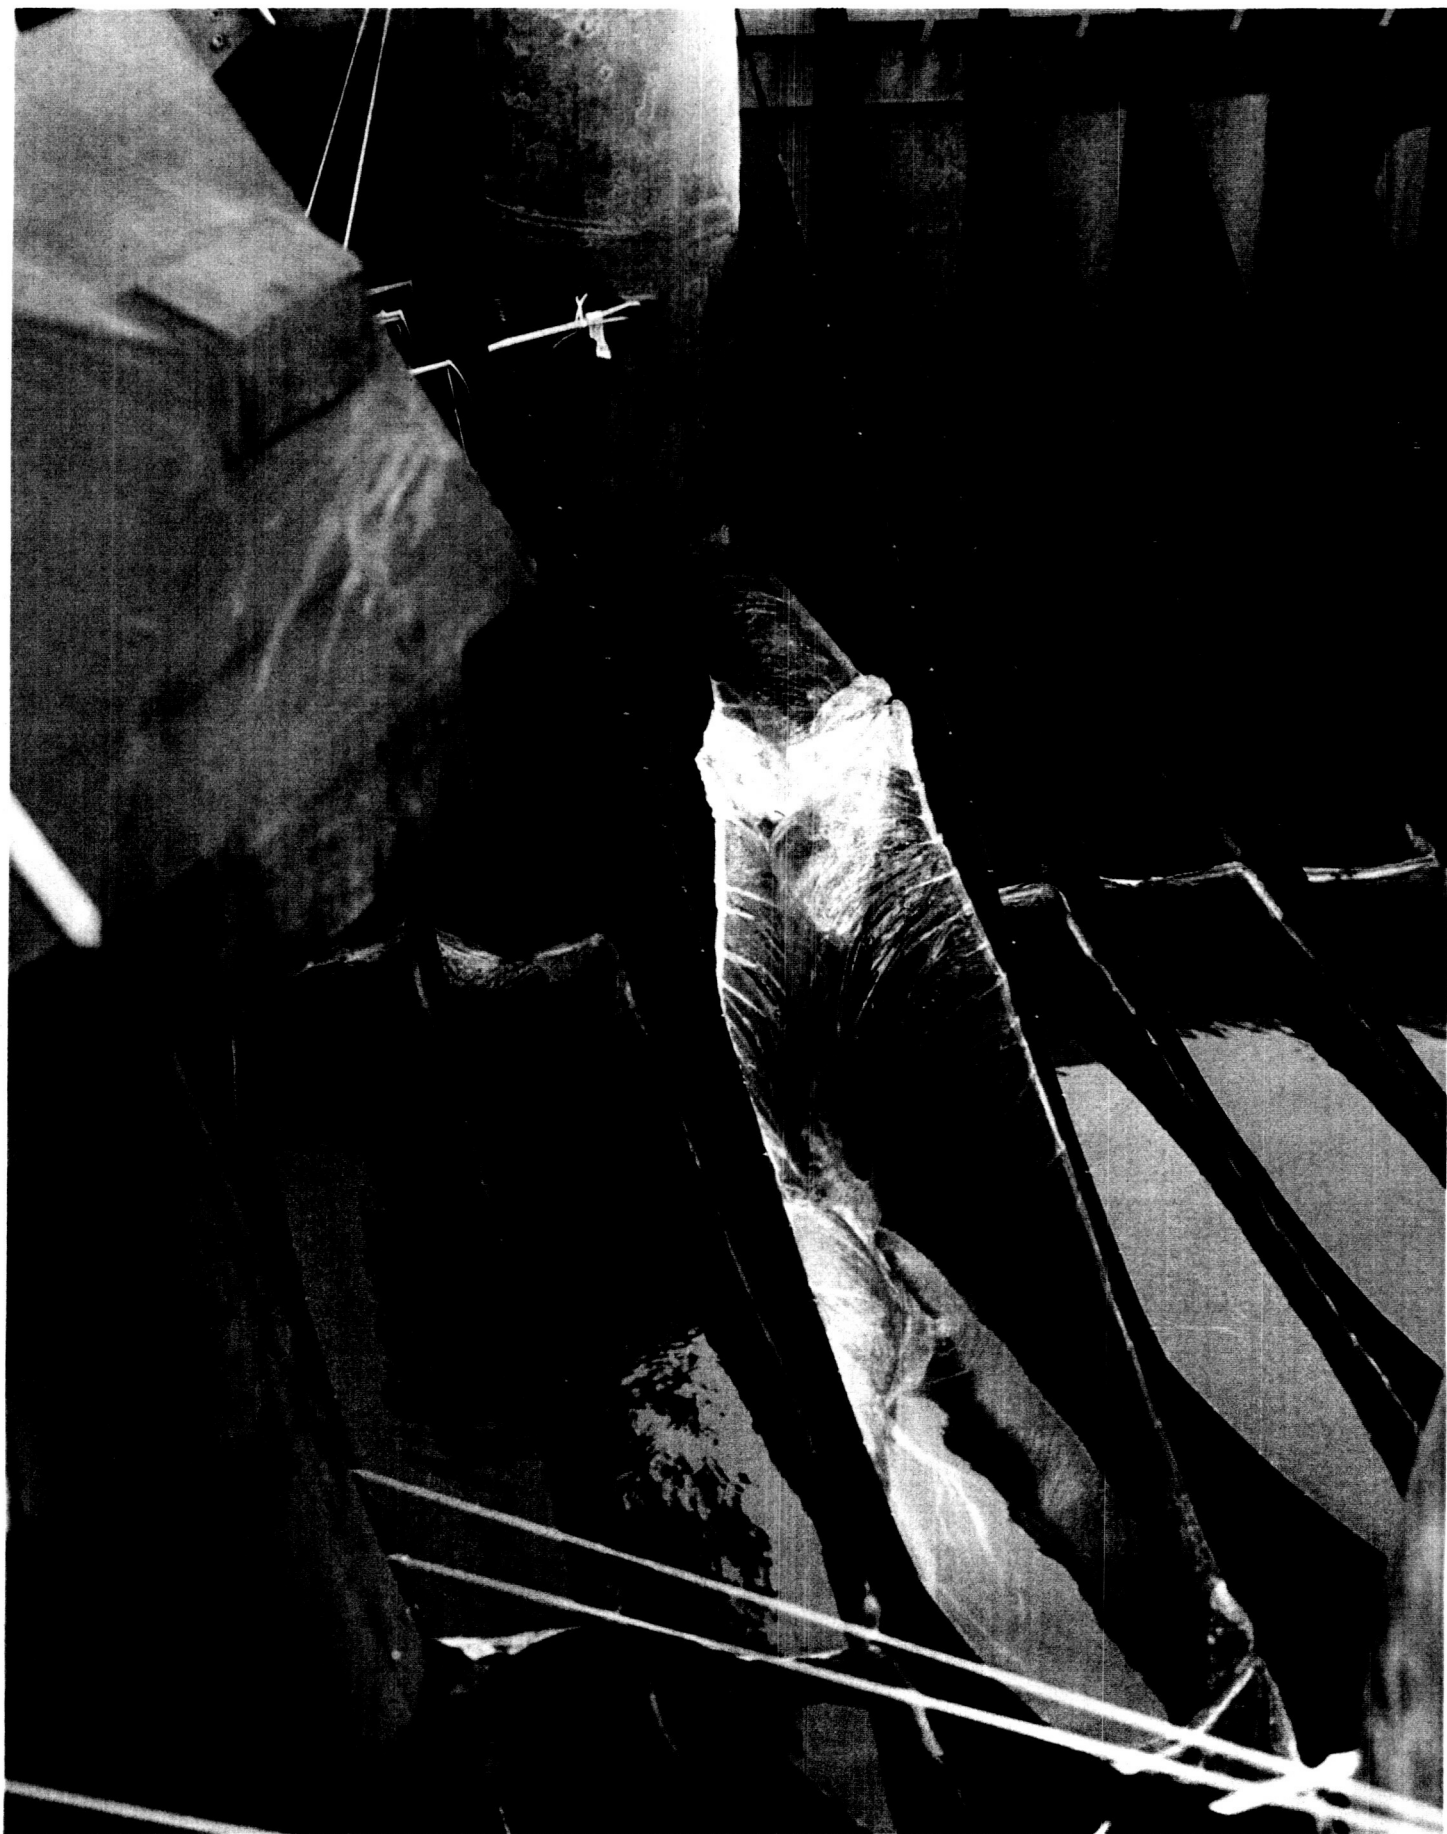
The third water trough (5th from the SRB nozzle) in the secondary sound suppression group had leaked and was nearly empty. Review/analysis/discussion by the launch team and Mission Management Team determined this condition was acceptable for launch.

The RH SRB secondary sound suppression water trough
(5th from the SRB nozzle) had leaked and was nearly empty

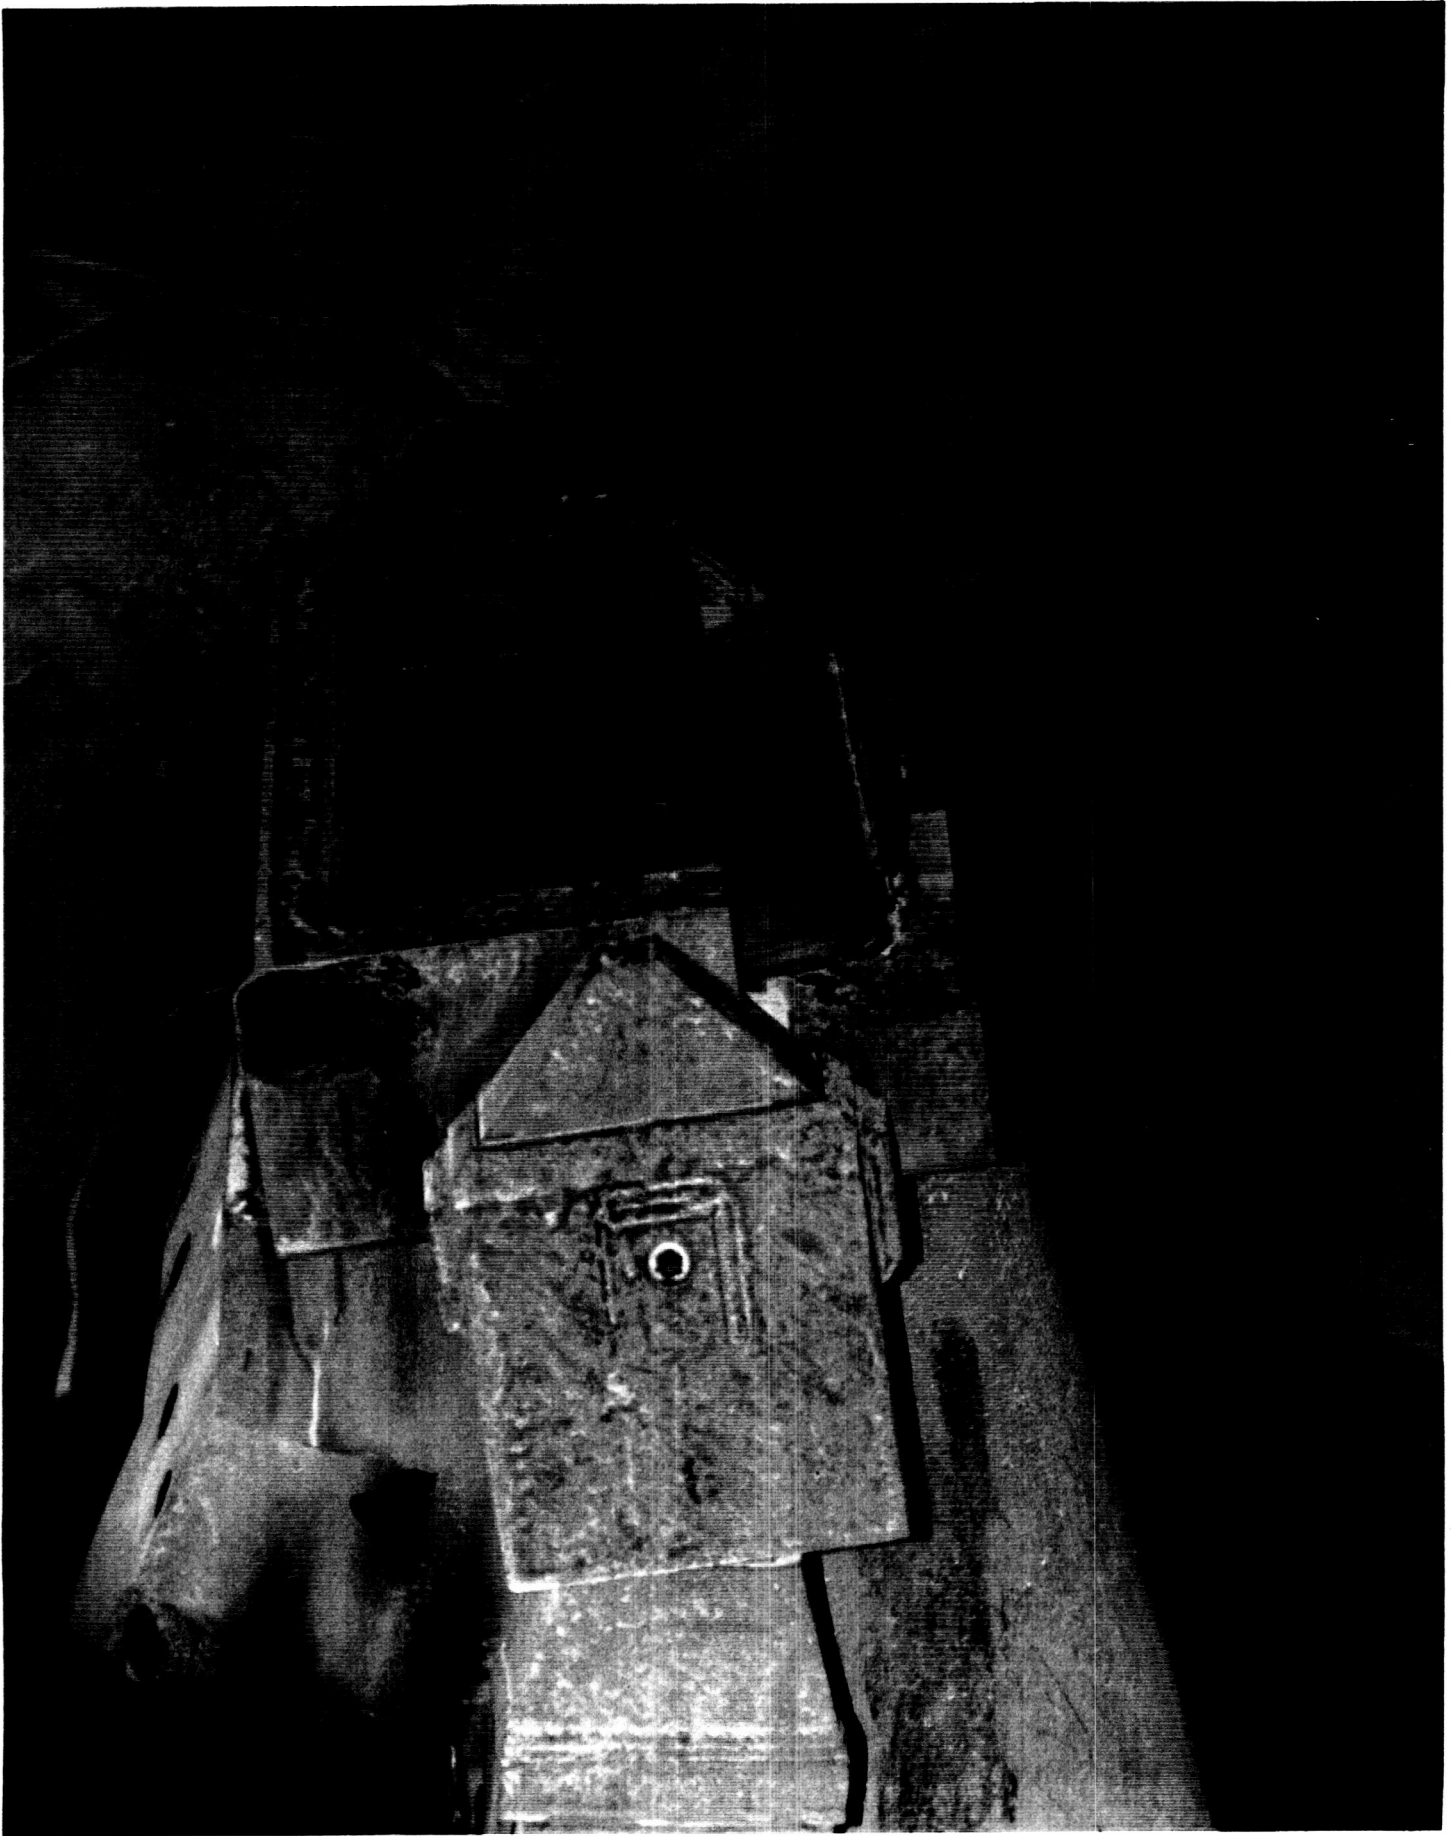
EA 934 shim material on the south holddown posts had debonded
from the holddown post shoes

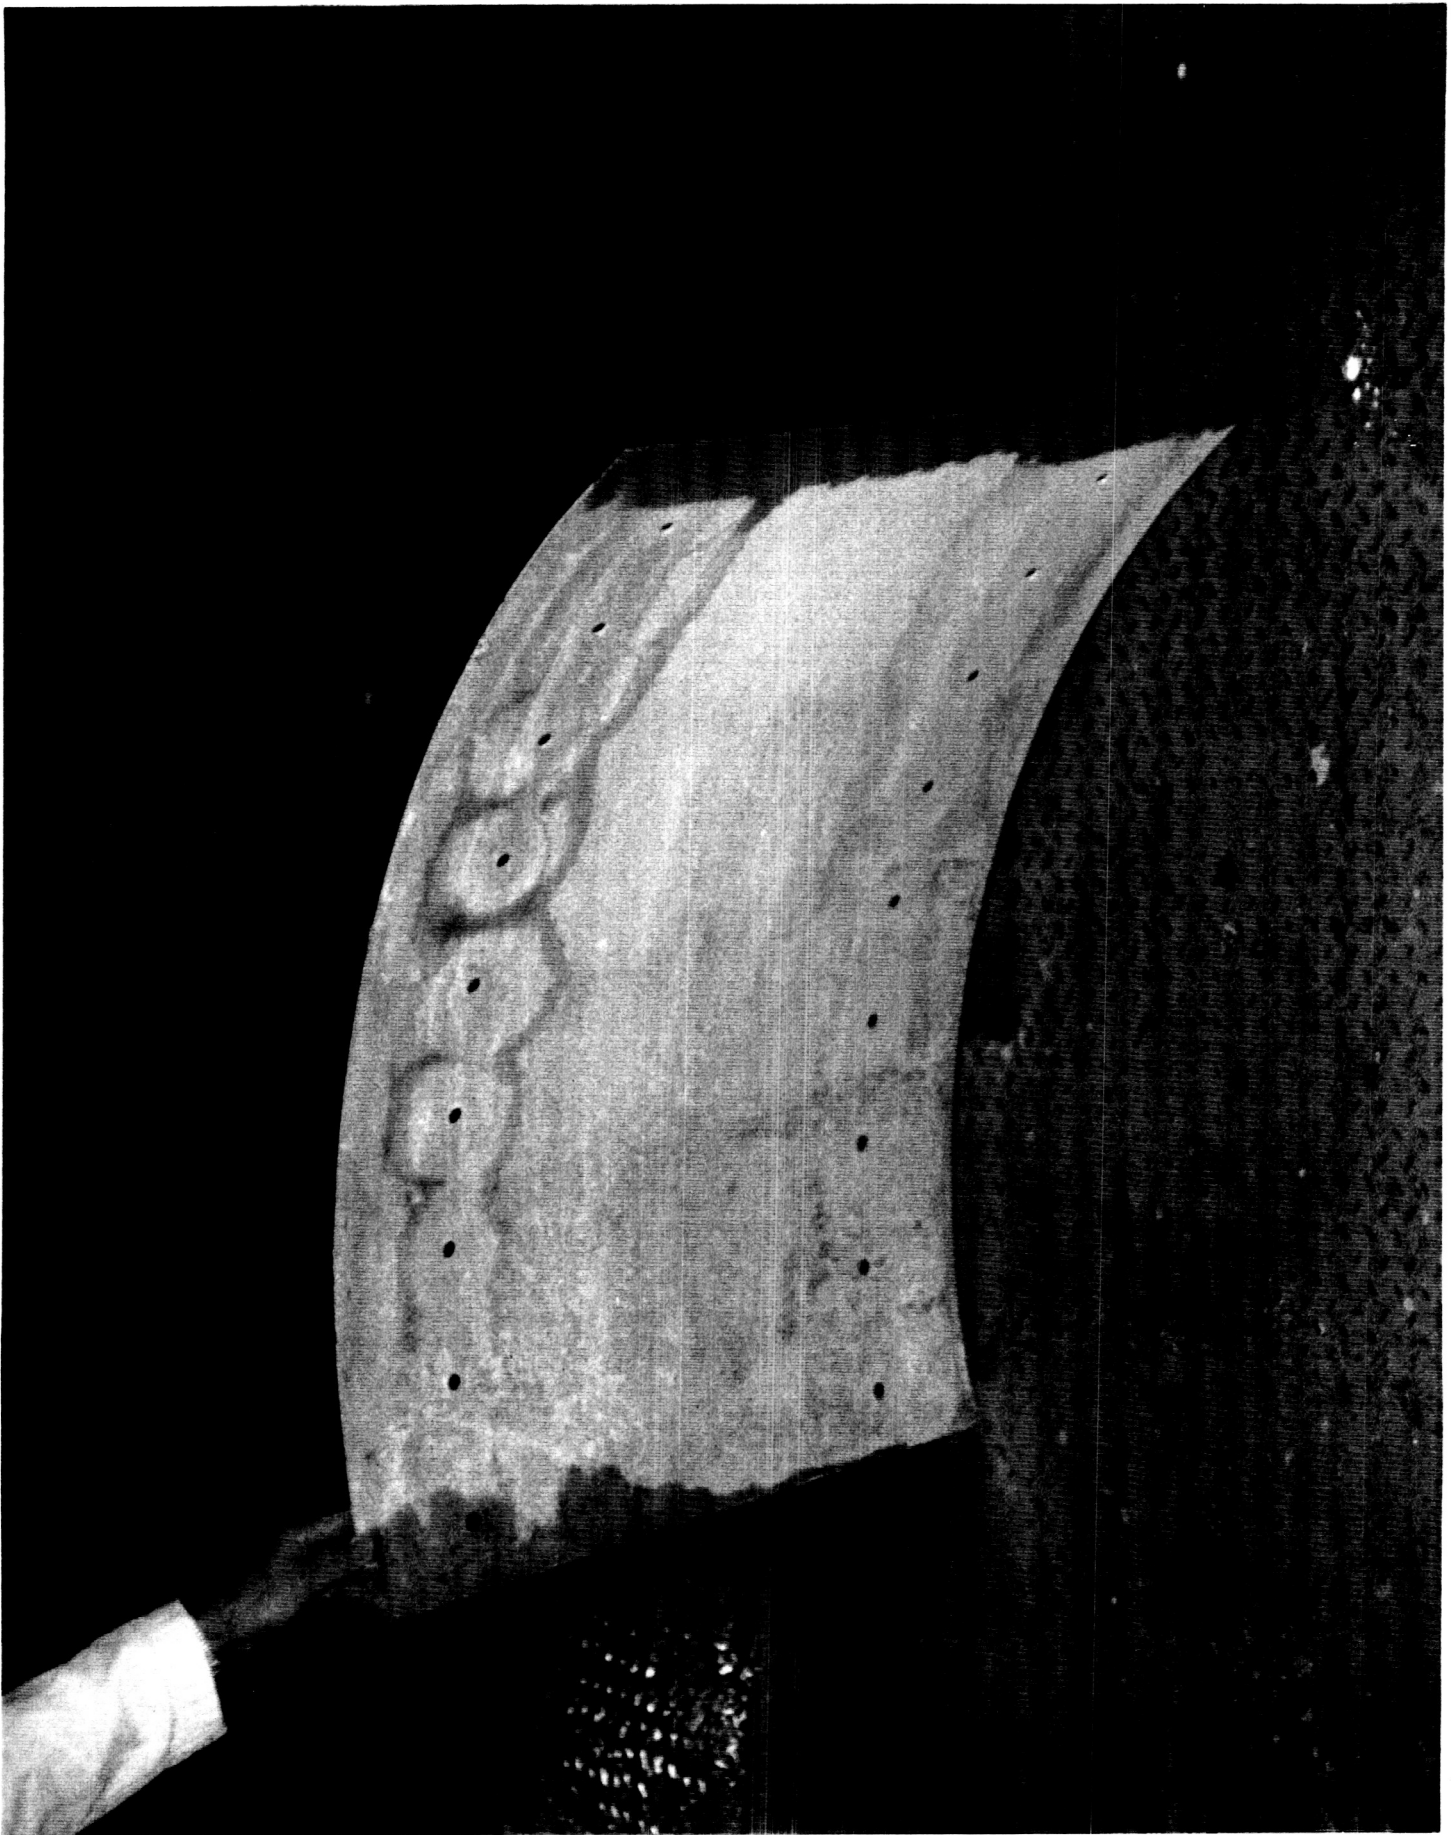
A 3'x2' aluminum facility cable tray cover was found
on the RSS 140 foot level

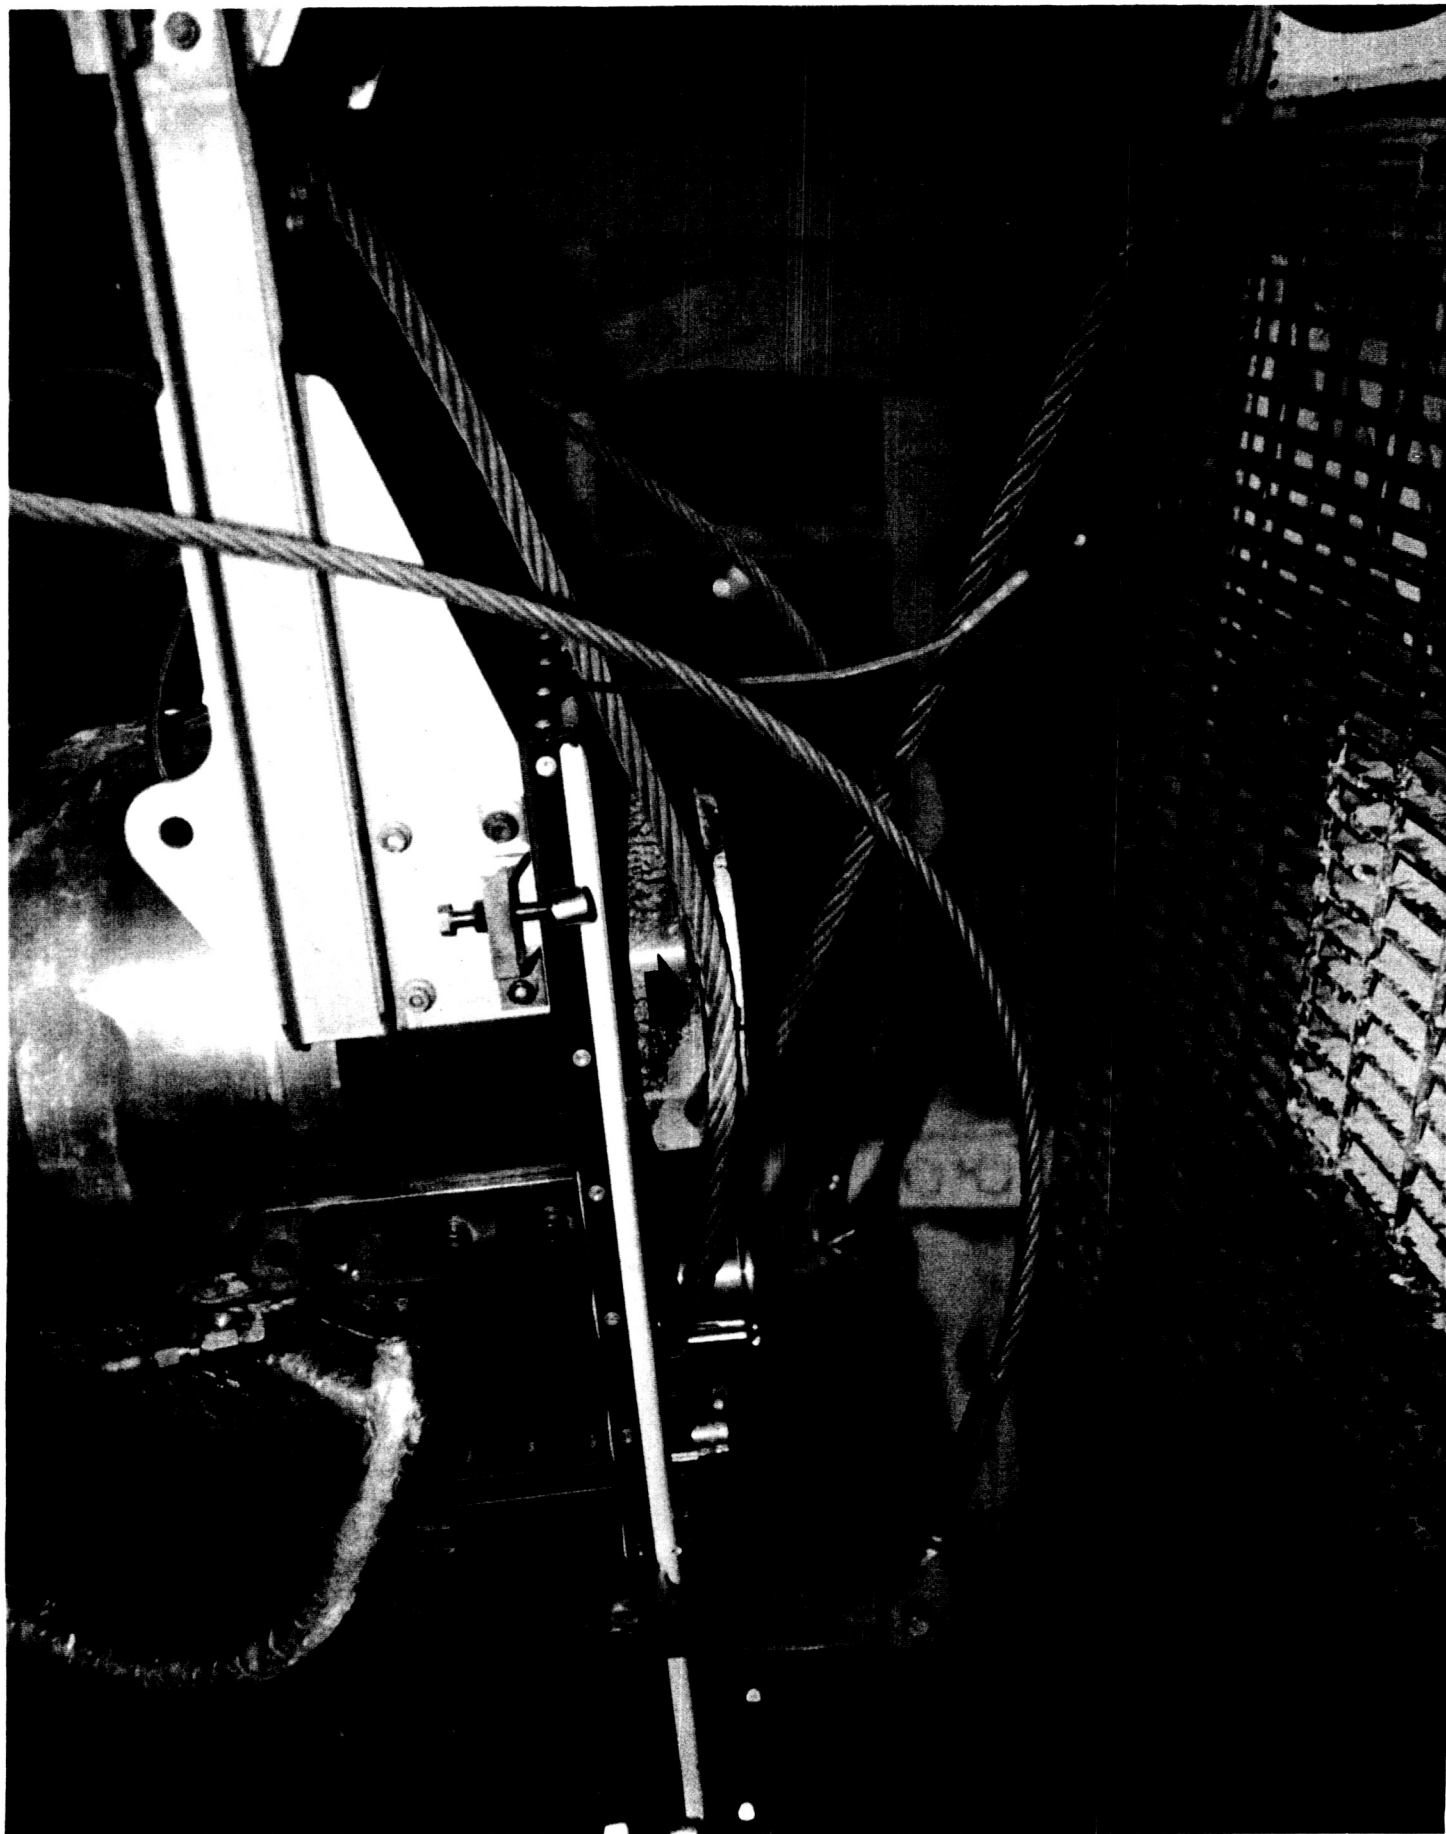
The GH2 vent arm retract lanyard wrapped around the swivel housing and damaged the 7-inch QD sealing surface

There were no major facility anomalies. No swing arms or other pad structures contacted the vehicle during liftoff. The GH2 vent arm disconnected, retracted, and swung down to the latched position in a normal manner (E-33, 35, 39, 41, 42, 48, 50). However, excessive slack remained in the retract lanyard which allowed the cable to wrap around the GUCP swivel housing.

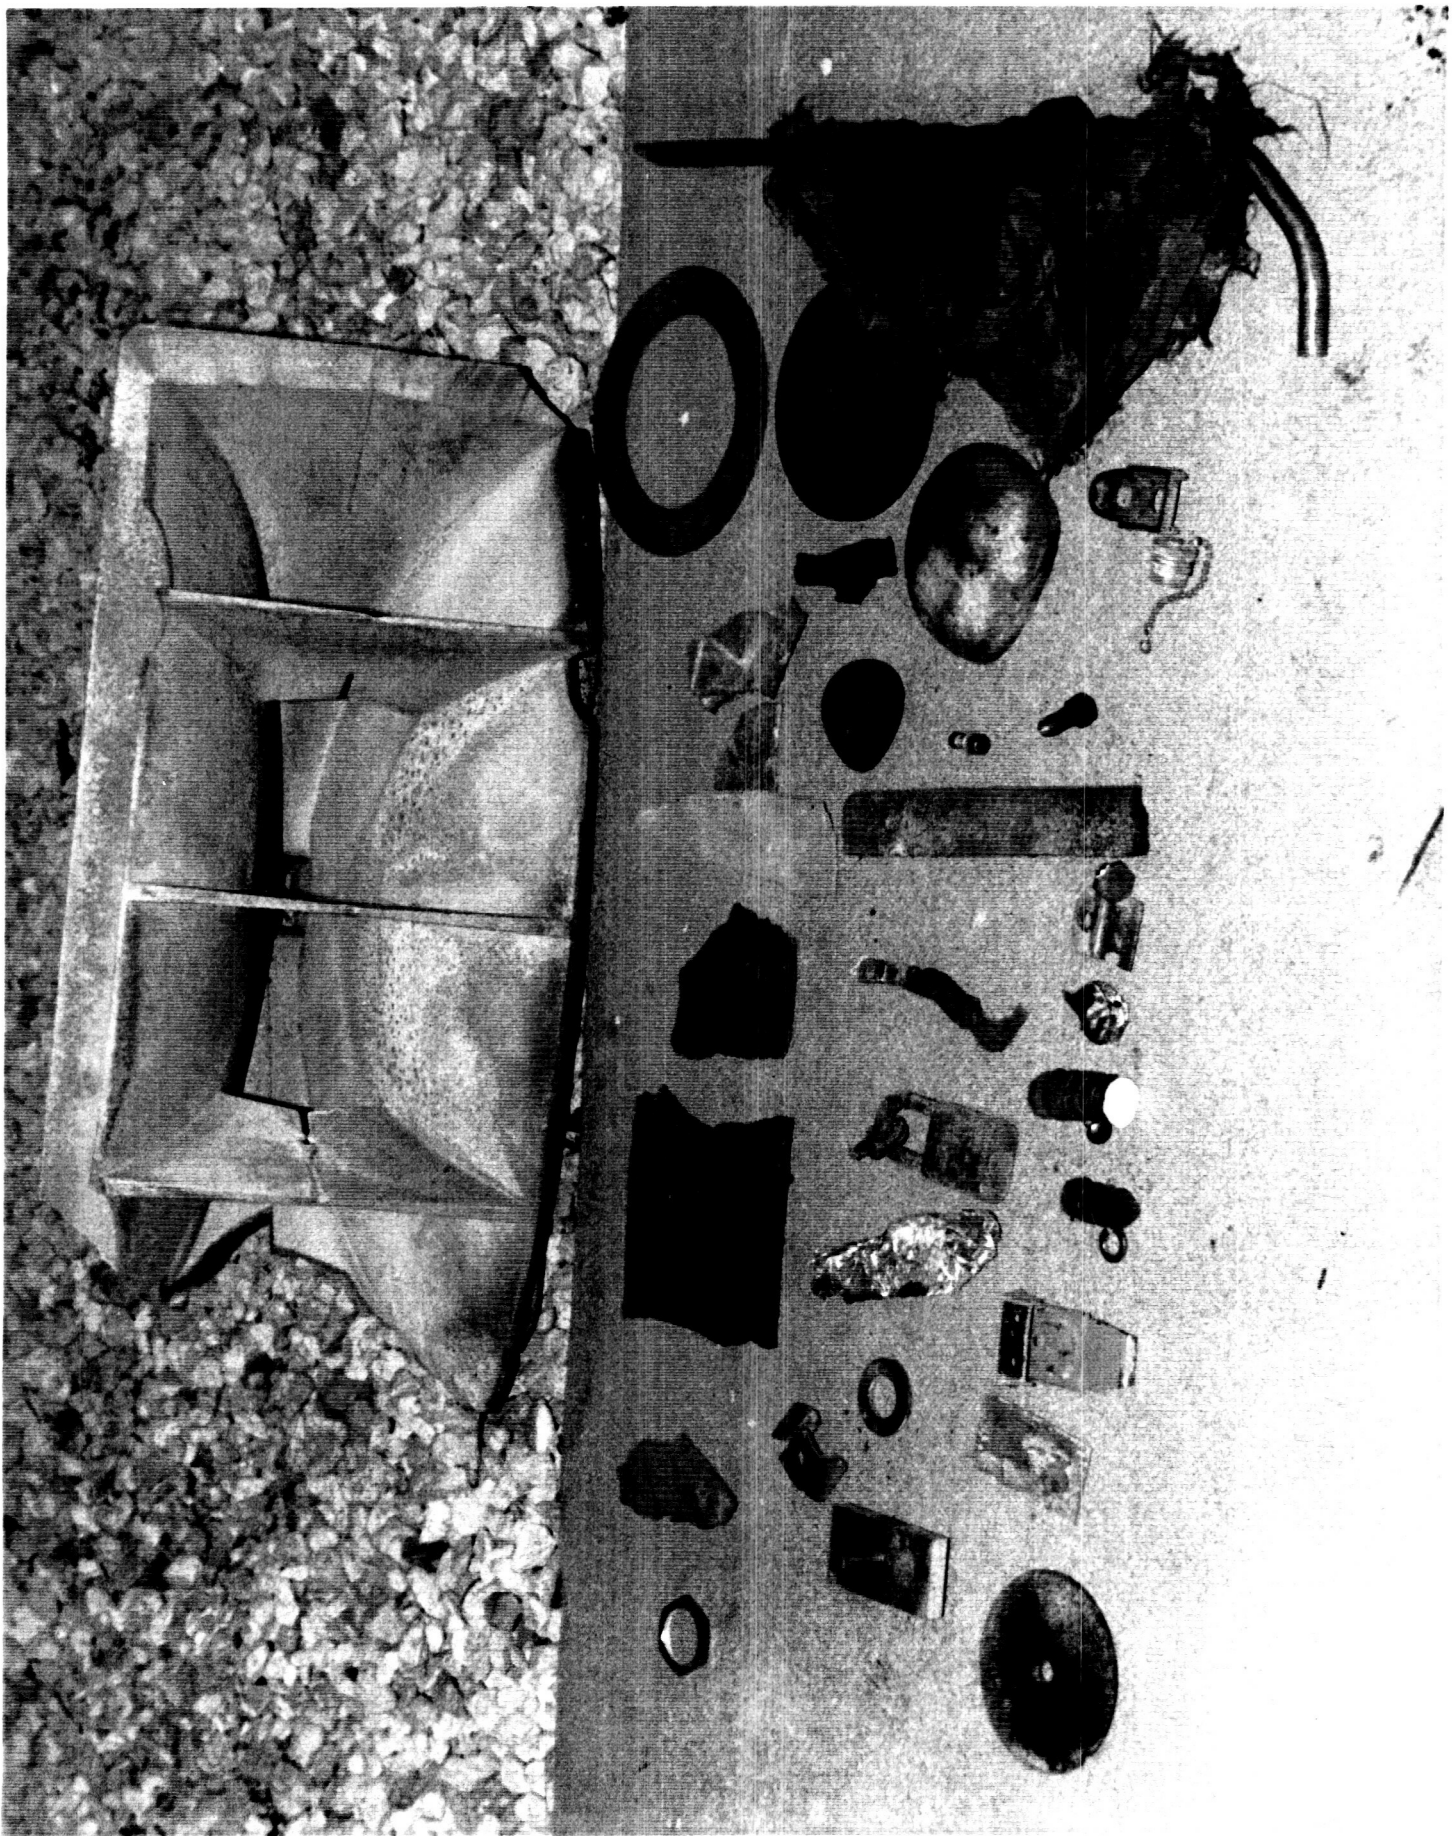
Typical debris recovered after launch. Q-felt plugs from the
Orbiter base heat shield area are usually found.

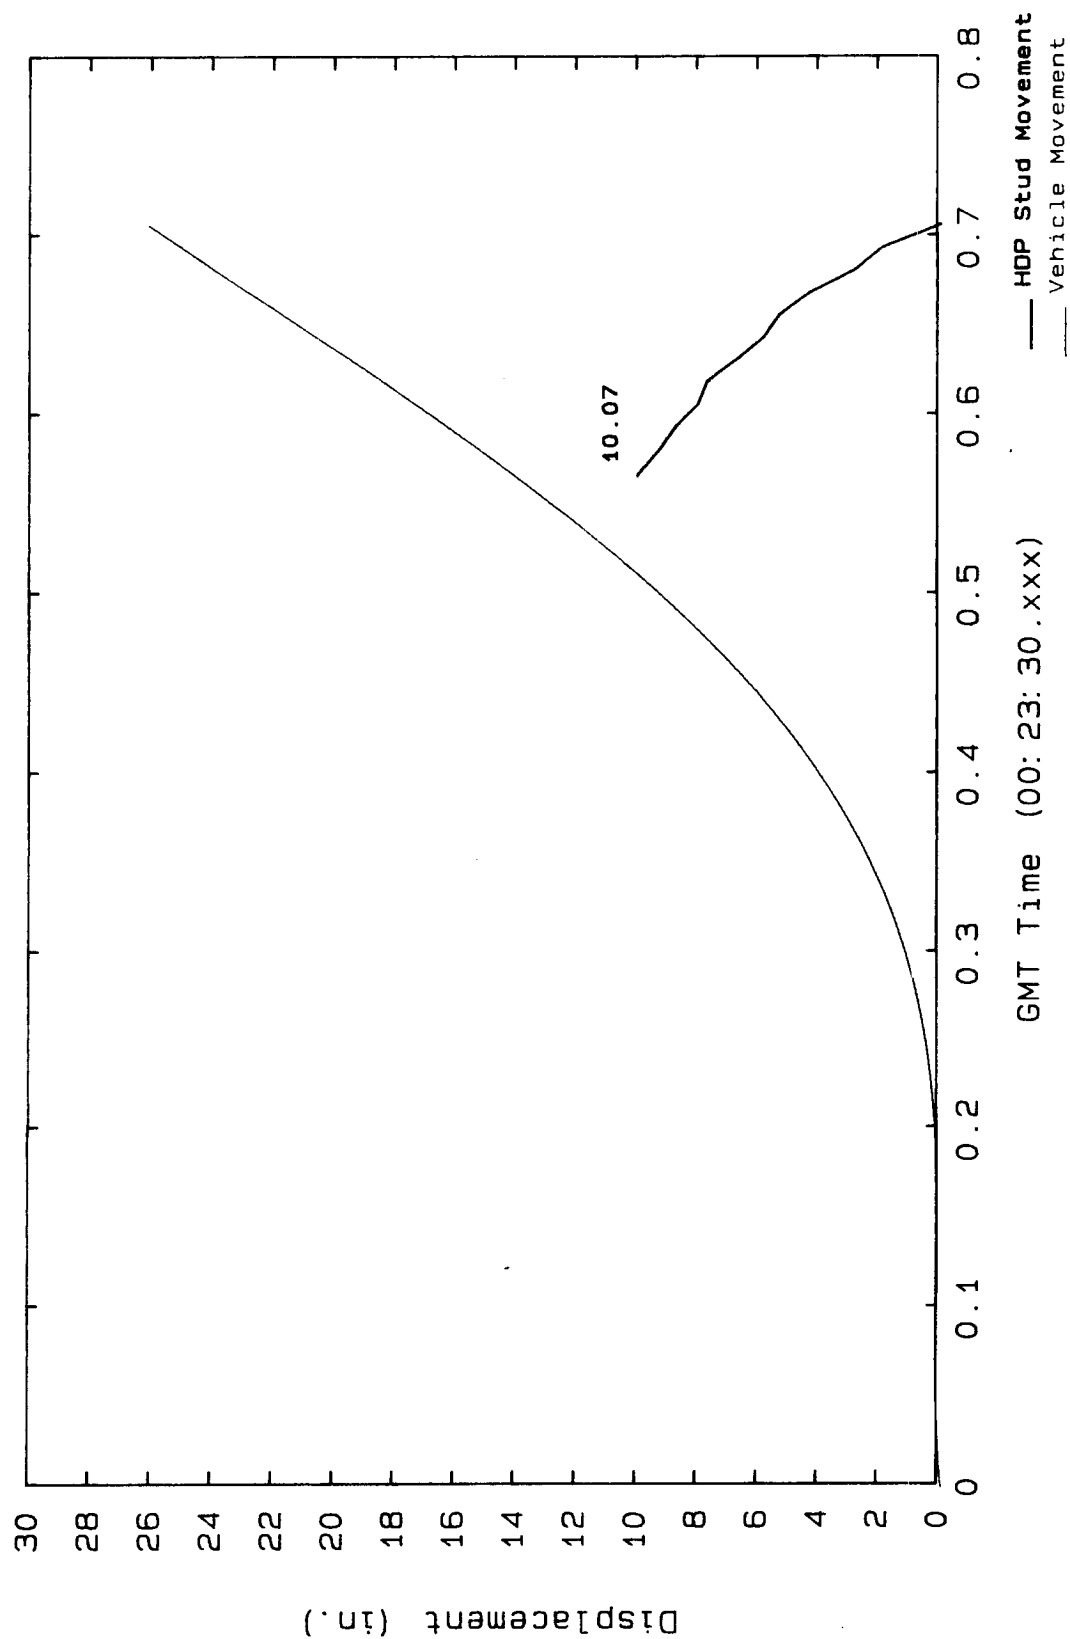
Figure 6. HDP #3 Motion Analysis

Orbiter yaw accelerometer data. As the vehicle separated from the holddown post shoe, MLP films showed the stud extended 10.07 inches as the aft skirt foot cleared the HDP doghouse blast cover. The stud contacted the aft skirt stud hole wall and loosened a piece of shim material bonded to the aft skirt foot. The piece of shim, which included the inboard sidewall and a cutout for the stud, fell from the aft skirt foot and disappeared into the SRB exhaust hole. Other MLP cameras documented numerous particles of debris, some measuring 5 inches in length, moving upward from the SRB exhaust holes at high velocities. Some of the particles, which appeared to have a mass greater than foam, came close to impacting the vehicle.

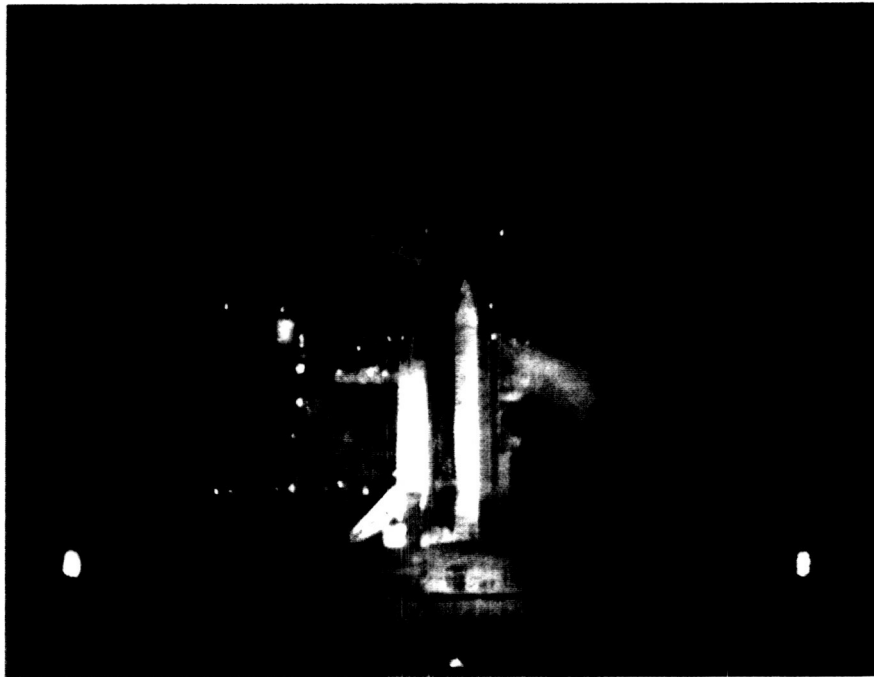
TV-7 shows free burning hydrogen blown north under the
Orbiter body flap during SSME ignition

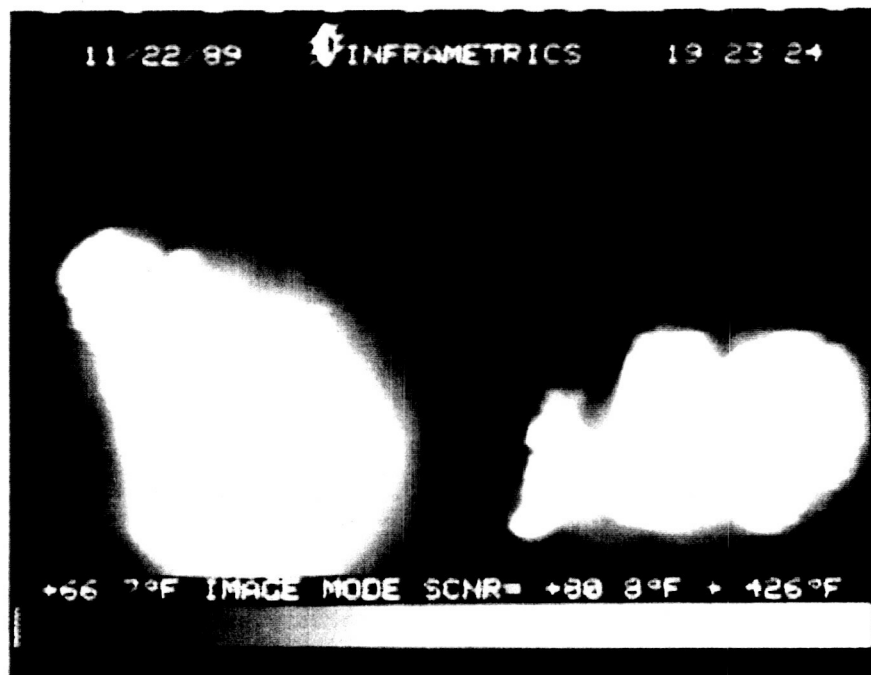
Shuttle Thermal Imager at Camera Site #2 provided infrared
images of free burning hydrogen blown north under body flap

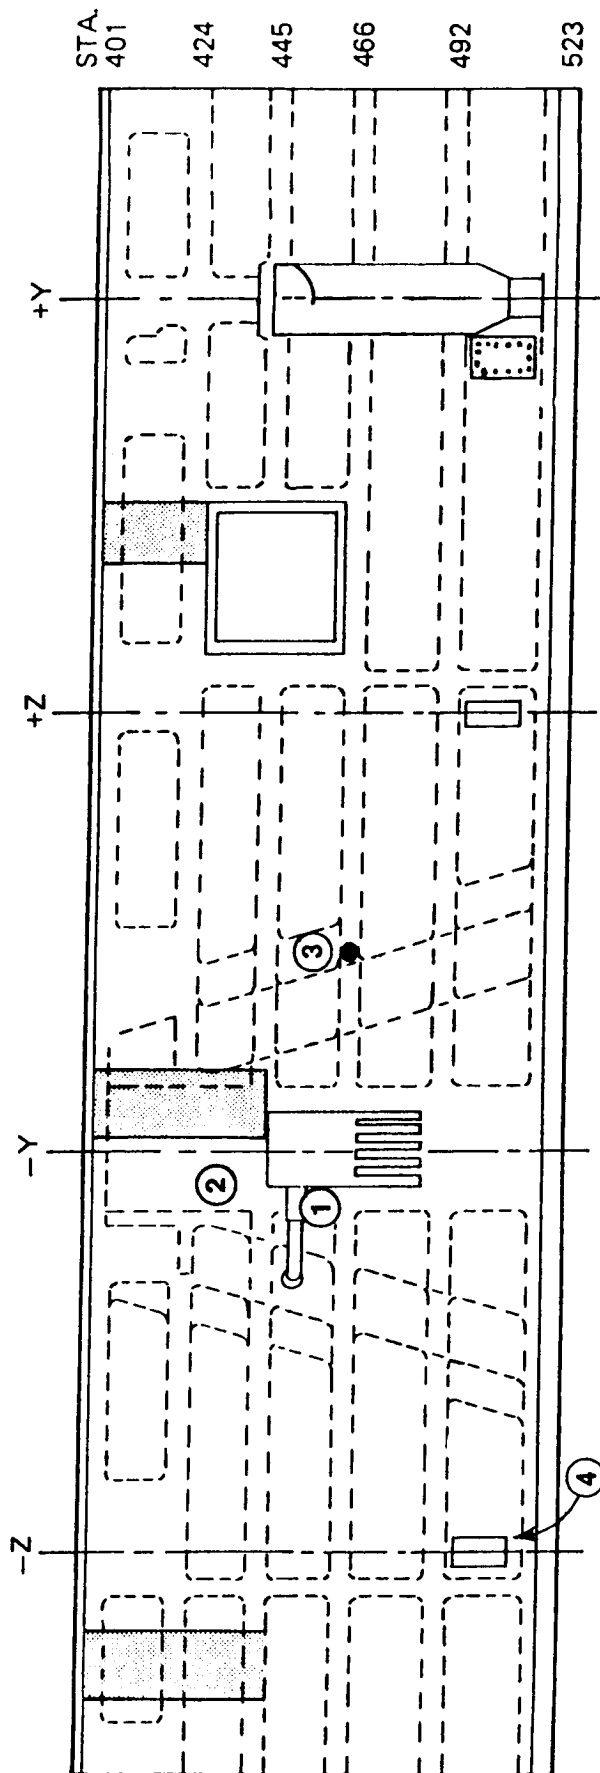
FIGURE 8. RIGHT SRB FWD SKIRT

TPS MISSING

- 1) CORK MISSING ON DISCONNECT
ASSY. 2" X 4"

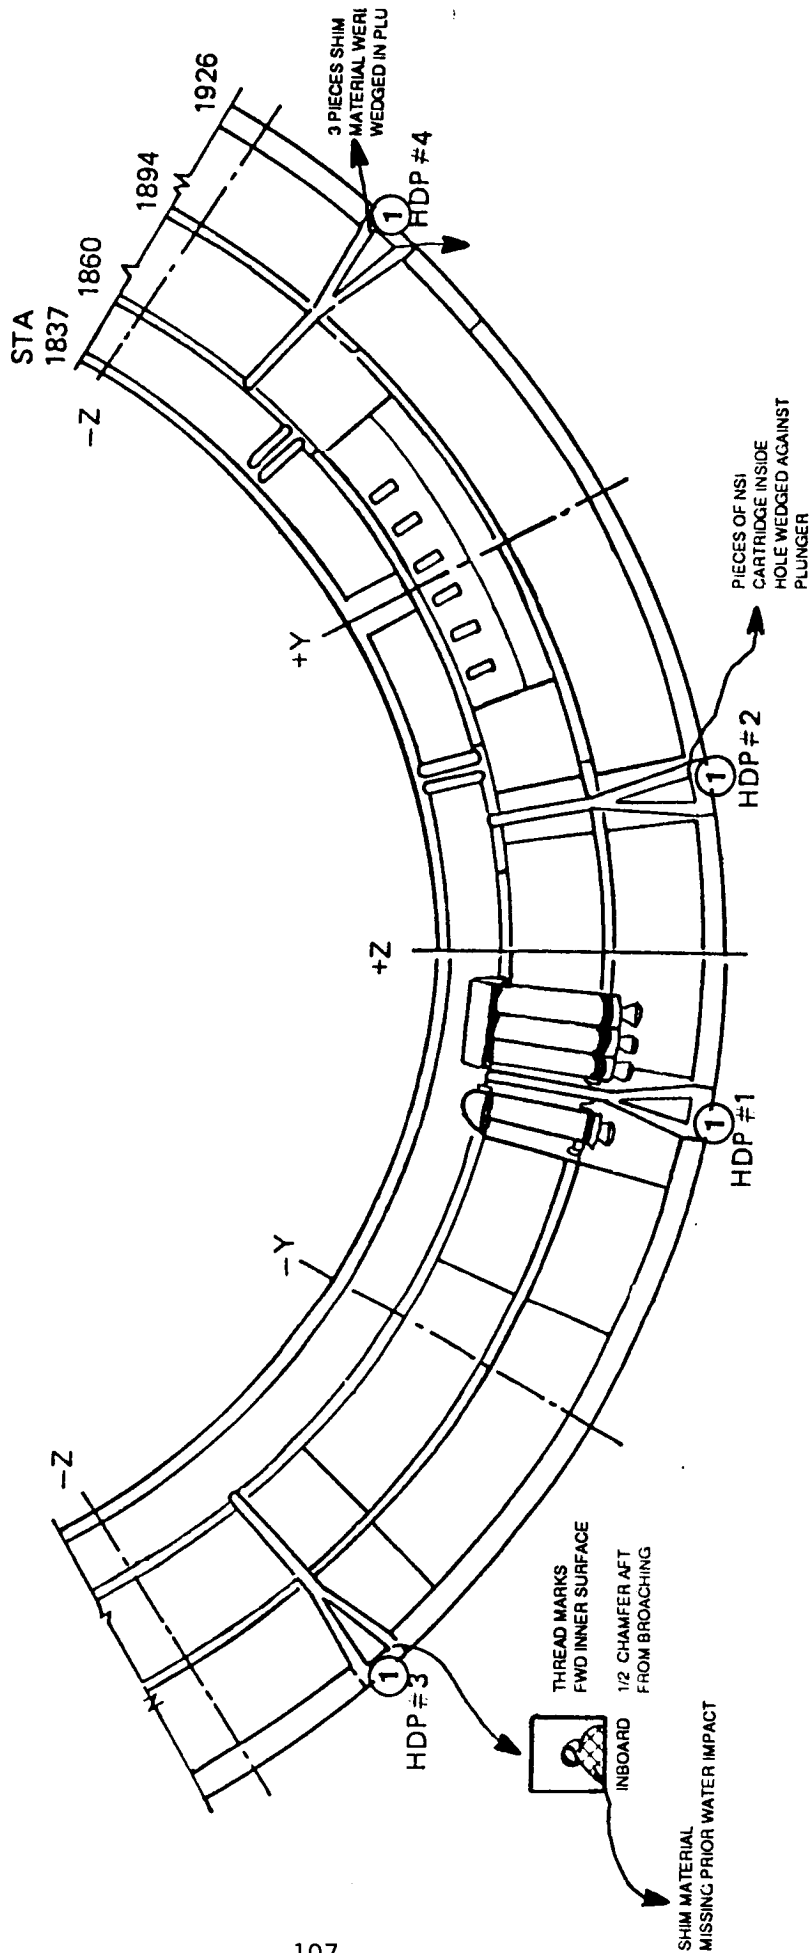
FIGURE 9. RIGHT SRB AFT SKIRT EXTERIOR TPS

1) K5NA MISSING

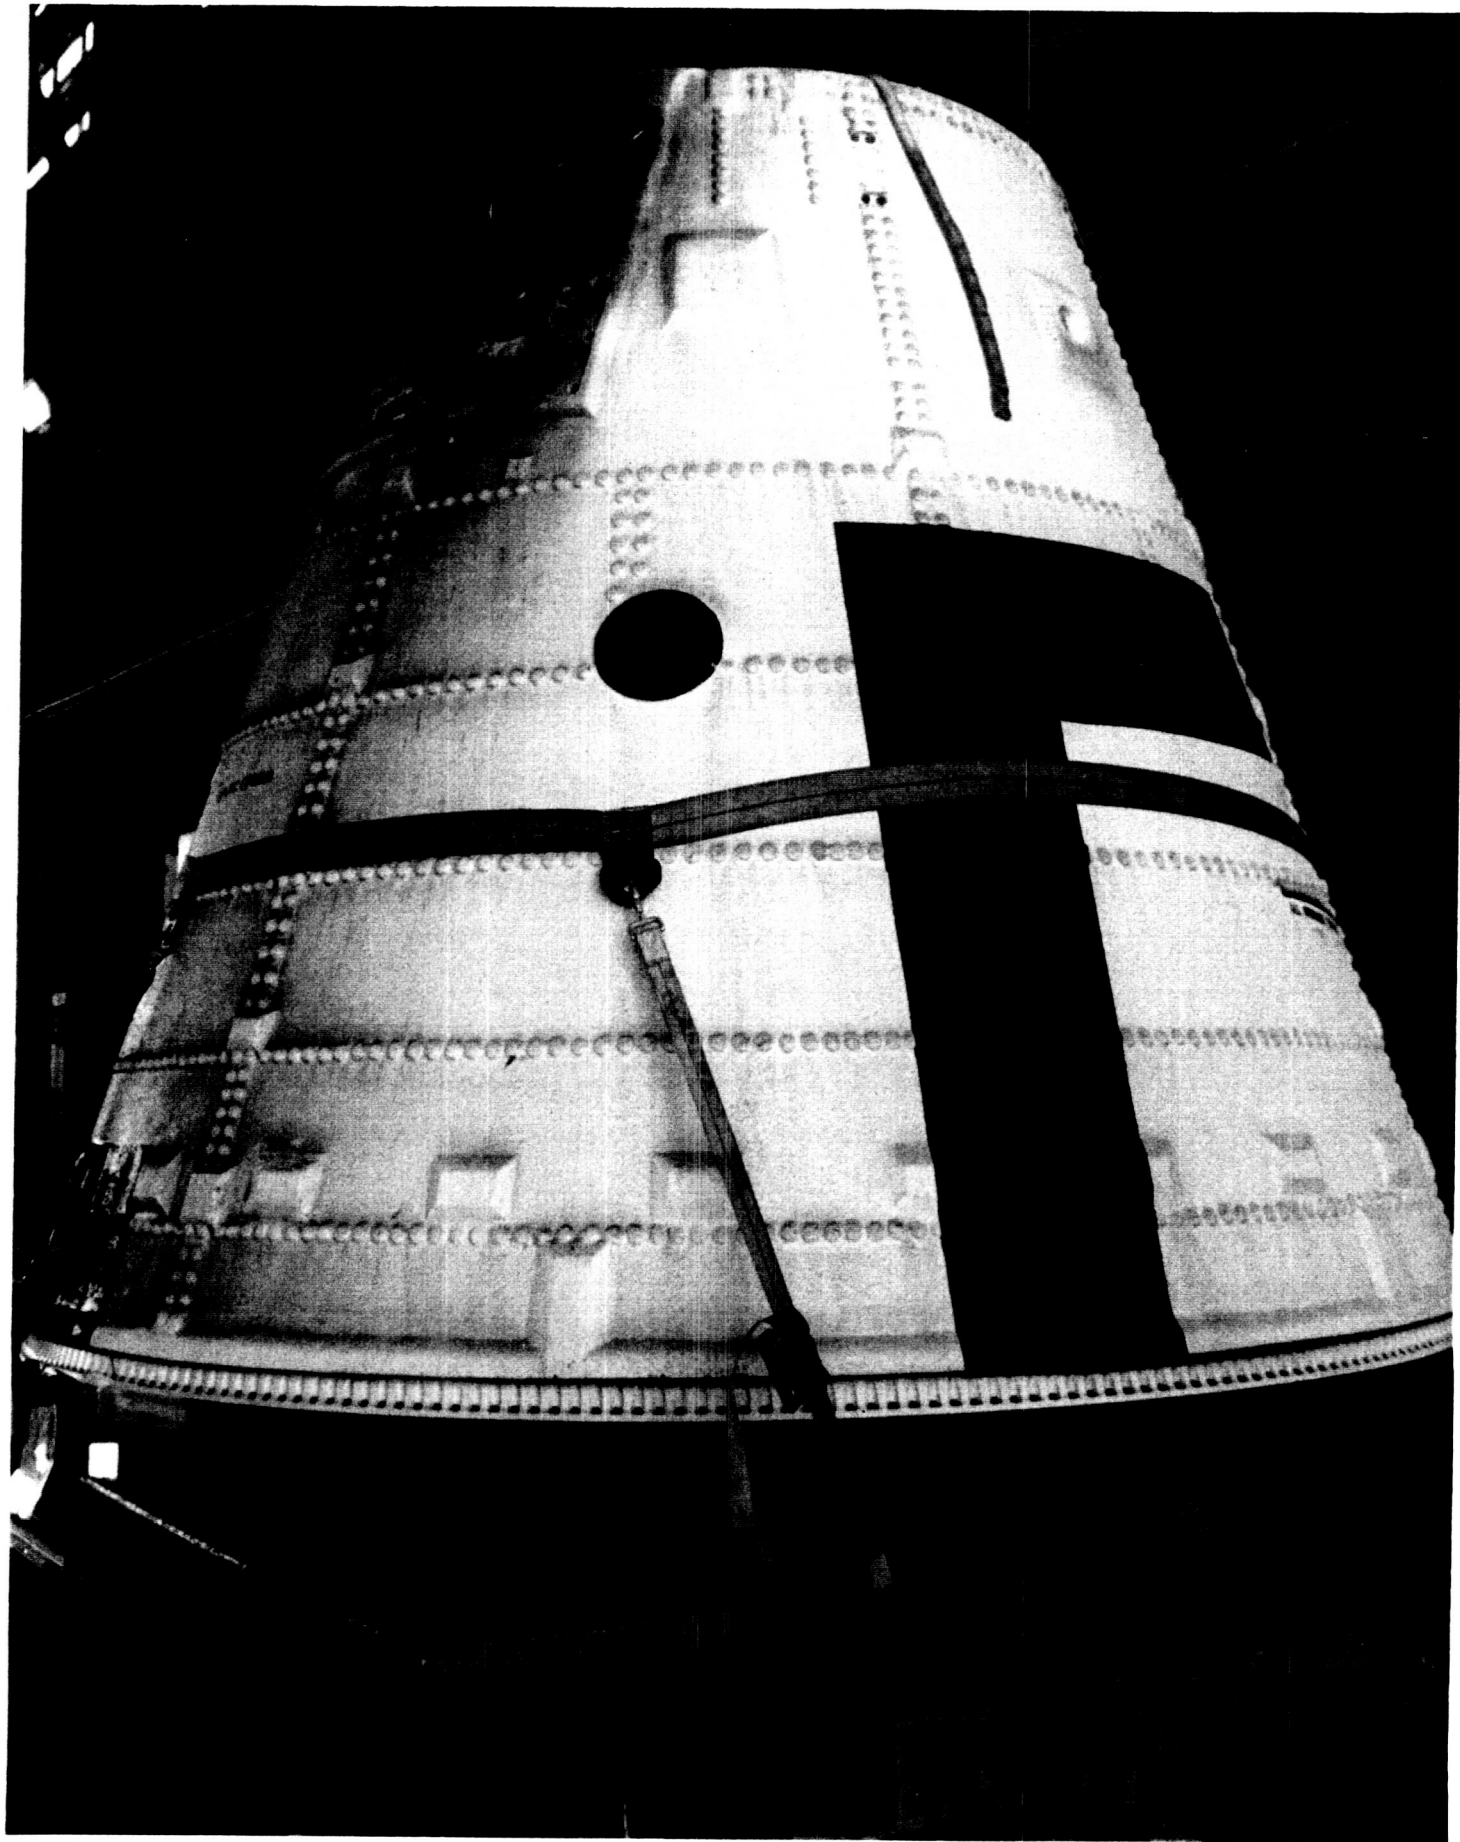
Overall view of RH SRB frustum. Blistering of the
Hypalon paint was minimal.
